Řopík bunkers – construction of border fortifications in 1937

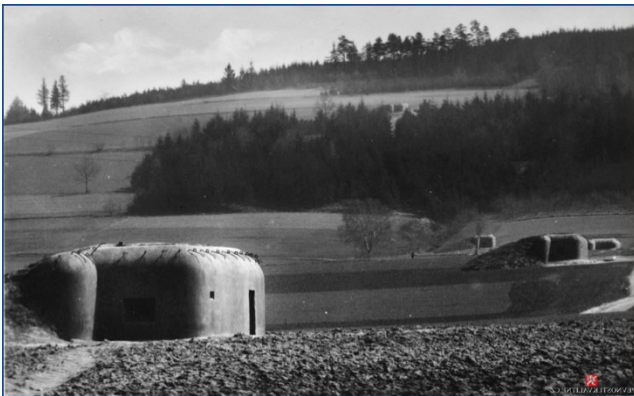
Left: Line of *řopík* bunkers in open terrain.
